Veritas Appliance

Hardware Service Procedure

Replacing an OS disk drive in a 3340/3350 compute node

Document Number: 247

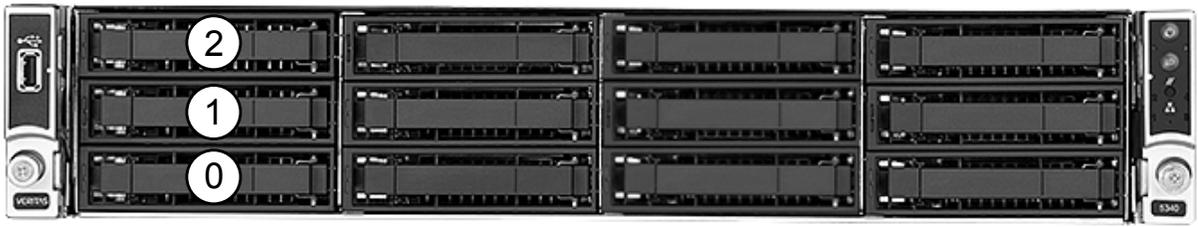
The 3340/3350 Appliance operating system is installed on two internal RAID 1 (mirrored) 2TB hard disks. The operating system disks are located in drive bay slots 0 and 1. A hot spare disk resides in slot 2.

Caution: For the 3340/3350 Appliance, only 2TB drives can be used in slots 0 and 1. Make sure you do not replace the faulty drive with any other size drive.

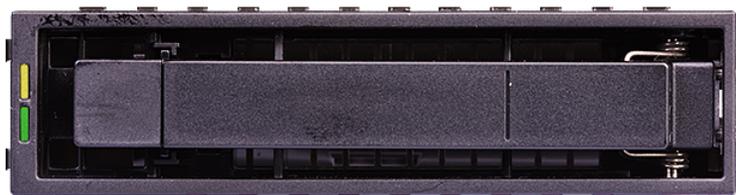
Drive Status LED —

- 1 Go to the unit with the faulty disk drive.
- 2 In the front panel, look for a solid amber Drive Status LED. The Drive Status LED is the top status light of the two LED lights that appear on the disk drive face plate. If the LED is blinking amber, the disk drive is in the process of rebuilding and must not be disturbed.

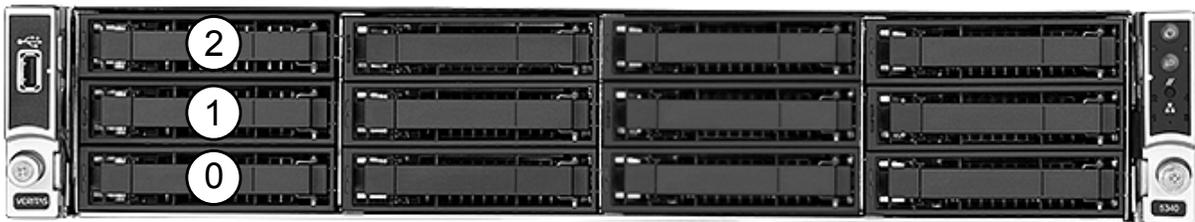
- 1 Put on an ESD-compliant wrist strap or take other ESD-protective measures.
- 2 If applicable, remove the front bezel on the compute node.
Unlock the bezel using the supplied key.
- 3 After unlocking the bezel, grasp the left side of the bezel. Pull the bezel away from the appliance to dislodge the remaining two tabs that hold the bezel in place.
- 4 Set the bezel aside.
- 5 Locate the drive that you want to replace. The drive must be in either Slot 0 - 3 and the Drive Status LED should be solid amber. The drive slots are shown in the figure below.

Note: Slot 2 contains a hot spare disk drive.

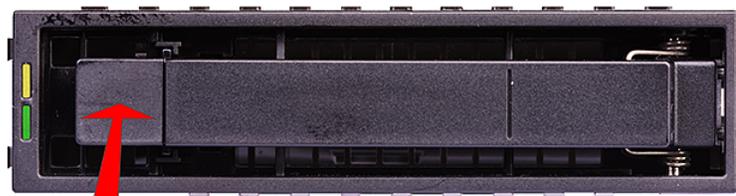
- 6 Press the release tab on the left side of the drive carrier to release the disk drive carrier lever.

- 7 Pull the lever open completely but do not slide the drive out of the slot. Let the drive motor stop spinning, which takes about 30 seconds.
- 8 Slide the drive carrier out of the slot.
- 9 Place the drive carrier and drive in an ESD-protective bag.

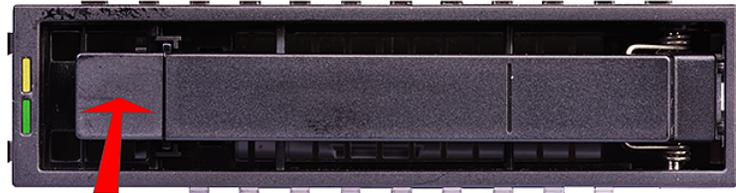
- 1 Put on an ESD-compliant wrist strap or take other ESD-protective measures.
- 2 Remove the replacement disk drive from the ESD-protective wrapper.
- 3 Press the release tab on the left side of the drive to release the disk drive lever.

- 4 Pull the lever open completely.
- 5 Slide the disk drive completely into the slot.
- 6 Close the lever. Make sure that the disk drive cover is flush with the front panel. The Drive Activity LED turns green when the connection is good. After a short period, the Drive Status LED will start blinking amber to indicate that the rebuild is in progress.
- 7 If applicable, re-install the bezel.
